POPPLETON HISTORIC STUDY

B-2543 MAGI #0425435504

18-22 N. Carey Street

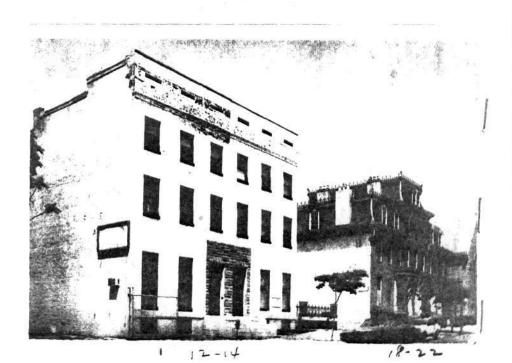
Notable features: Originally called "Linden Terrace," these three large houses represent a rather uncomfortable union between the severe Baltimore row house facade and the stylish Mansard with metal trim, dressy windows and other details. Like the houses on the Square, these should be protected and rehabilitated.

N.B. Between the 1930's, when the picture in the Pratt Library Maryland Room photograph collection was taken, and 1975, the window openings in the southern-most house have been altered by the introduction of arched window openings. Number 22 has more recent modifications to the entry column capitals, its cornice and dormer windows; it has also lost its roof iron. There are handsome metal yard fences.
